Manhole Inspection Summary

Manhole # S29GG_043MH

Insp Date: **12/29/06 8:48 AM**

Location Address: **1624 MCMECHEN ST**

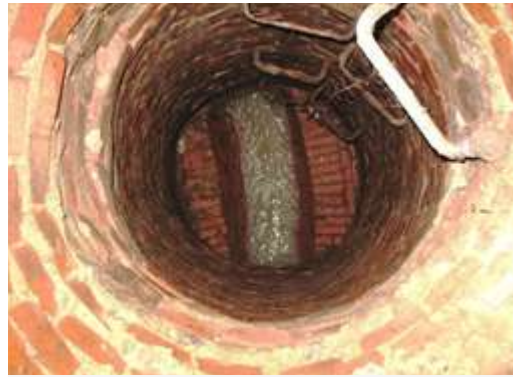
Top View

Condition: ☐ Sound ☐ Cracked ☐ Root Intrusion ☐ Loose Brick ☒ **Deteriorated**

Infiltration: ☐ None ☐ Joint ☐ Cracks ☒ **Mortar** ☐ Roots ☒ **Wall**

Steps Count: **7** Missing: **0** ☒ **Corroded**

Surcharge ☒ **Evidence Of Surcharge** Depth: **4.5** (ft.) ☐ Active Surcharge Present

Corbel deterioration and infiltration.
Corroded steps. Evidence of surcharge -
Bench debris.

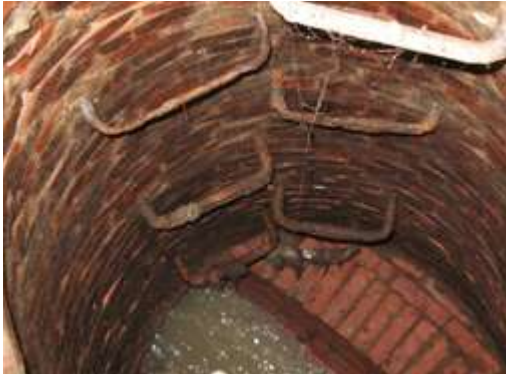
Defect

Infiltration: ☐ None ☒ **Joint** ☐ Cracks ☒ **Mortar** ☐ Roots ☐ Wall

Infiltration: ☐ None ☐ Joint ☐ Cracks ☐ Mortar ☐ Roots ☒ **Wall**

Adjustment, Corbel and Barrel infiltration.

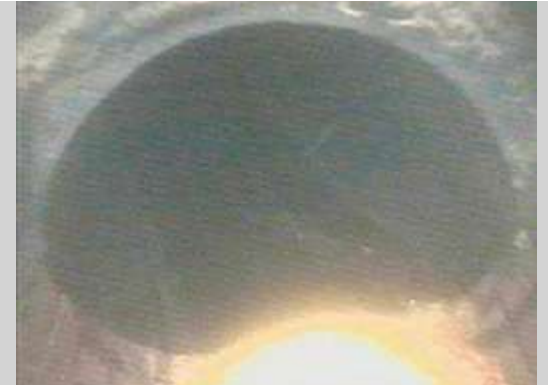
21 in. Circular Gravity Sewer Pipe Out @ 12 O'Clock

Infiltration: **Evidence** Pipe Seal Cond: **Cracked**

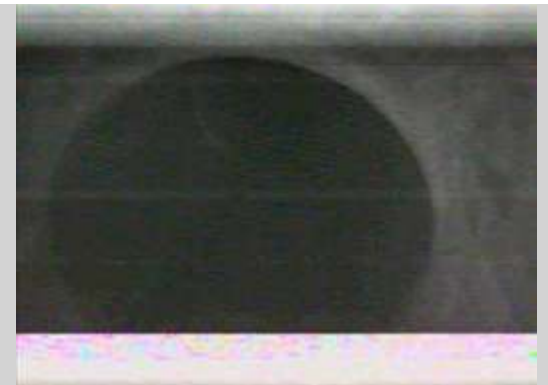
21 in. Circular Gravity Sewer Pipe In @ 6 O'Clock

Infiltration: **None** Pipe Seal Cond: **Unknown**
